09G TF60SN C2 Clutch Drum Bushing Repair Tool

**O9G VW Case
Bushing Repair
(2003 and up)**

O9G VW Case Repair (2003 and up)

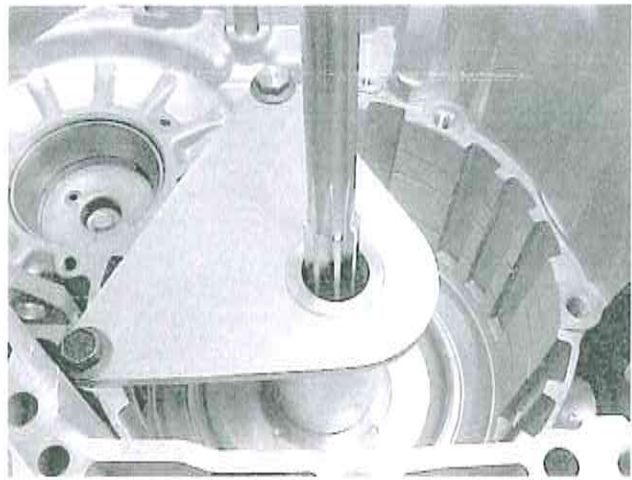
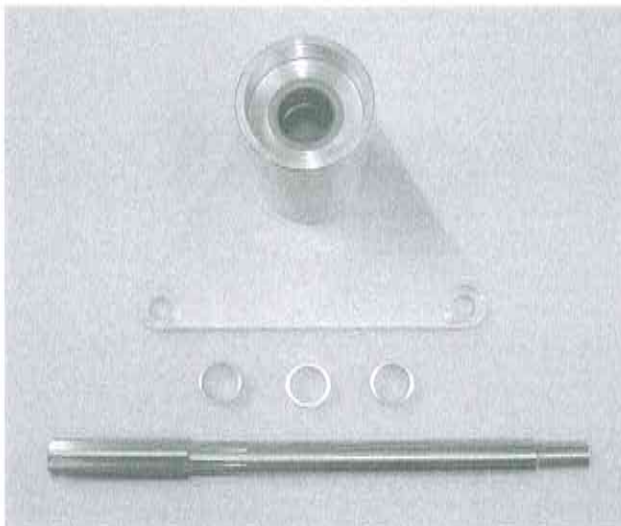
The center post at the rear of the 09G case holds a bushing that tends to ruin the case when it spins. In order to save the cases we have produced an oversize bushing.

Machining of the case is necessary to install the bushing. The sleeve at the rear of the case must fit firmly on the post. Three bushings come with the tool. Omega Machine is please to announce this tool so you can repair these cases in house.

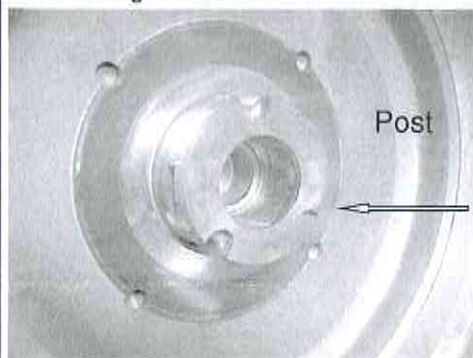
Problem: This post supports a sealing ring sleeve. The center of the post holds a bushing that tends to ruin the case when it fails. Getting the bushing out is difficult.

Omega is supplying an oversize bushing to replace the stock bushing. This is part number 90448A.

If the case fit is bad, follow the instructions below. If the sealing ring sleeve is loose, fix that first.

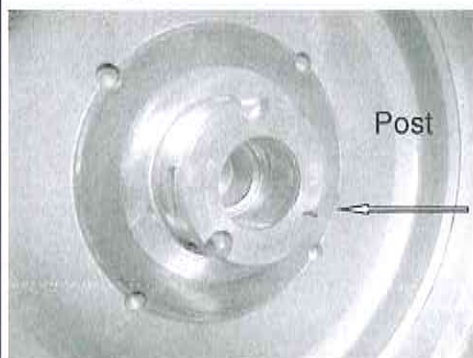
Post

Problem: This post supports a sealing ring sleeve. If the sleeve comes loose, it blocks the port. The bushing in the center tends to self destruct and ruin the bushing fit in the case. This procedure addresses both of these problems.
